WATER QUALITY REPORT PREPARED FOR:
MINNESOTA LEGISLATIVE-CITIZENS COMMISSION ON MINNESOTA RESOURCES

MAPLETON AREA AGRICULTURAL + URBAN RUNOFF ANALYSIS

SOUTHERN MINNESOTA - BLUE EARTH COUNTY DITCH NO. 57 (CD 57)

PREPARED ON BEHALF OF:
THE BLUE EARTH COUNTY DRAINAGE AUTHORITY

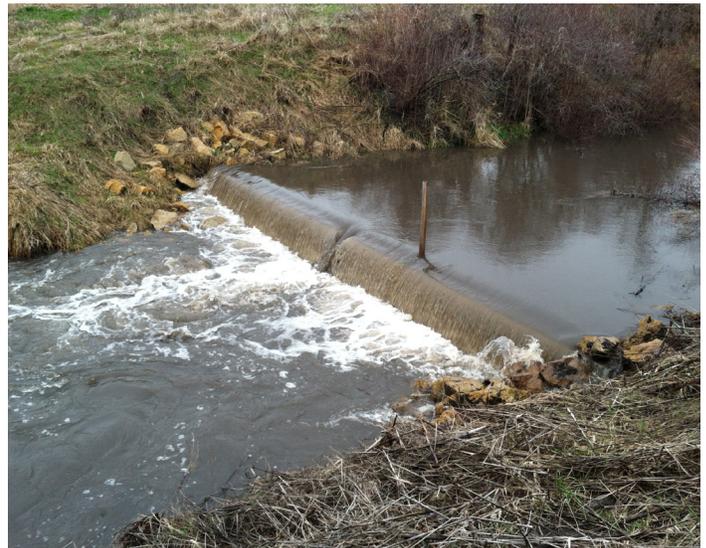
Figure 2 - Rate Control Weir Storing Water

The photograph (Figure 2) of the rate control weir shows its effectiveness

at storing water during a rain event.

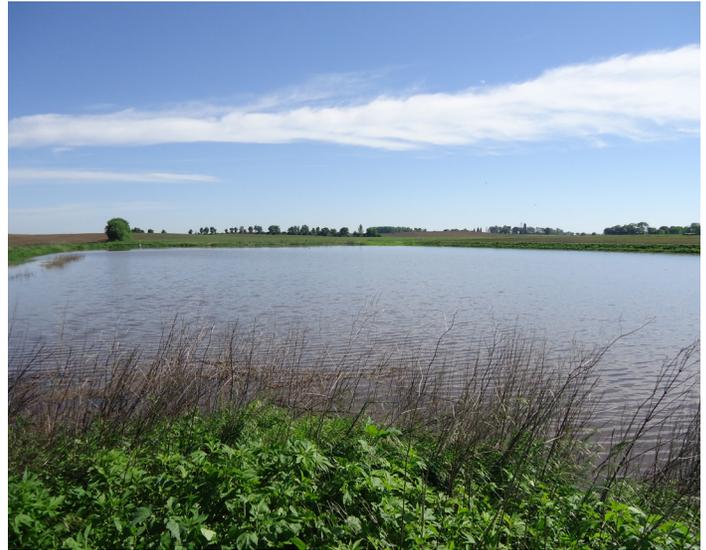
Figure 9 - Klein Pond after 25-Year Rain Event

57 system near the Cobb River, which reduces peak flow rates from the system. The Klein surge basin (Klein Pond) was constructed to store runoff from surrounding farmlands of the upper portion of the watershed. The City of Mapleton's stormwater pond, known in this report as City Pond, was expanded to store runoff from the City and portions of the upper watershed. A two-stage ditch was installed to mimic the conditions that exist within naturally flowing streams that limit in-channel sedimentation. A sediment trap was installed to create in-channel treatment of sediment by over digging portions of the ditch, allowing for sedimentation to occur. Overall, this improvement project provided storage and treatment for agricultural and urban runoff in an effort to improve drainage, water quality, and increase diverse habitat.

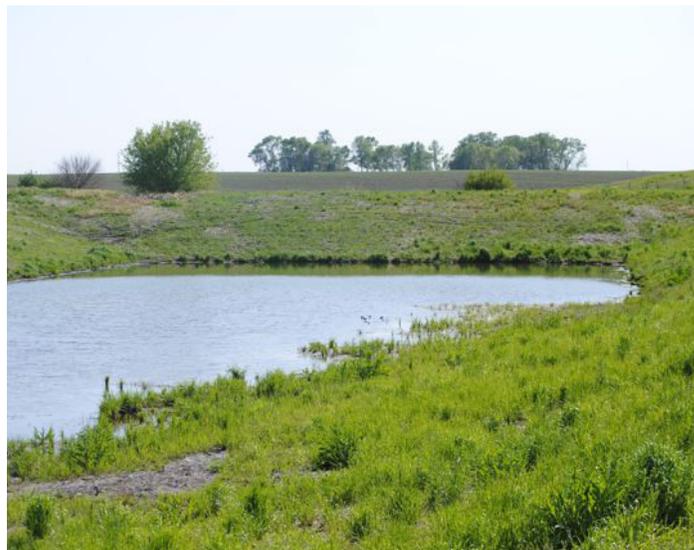
Figure 11 - City Pond (Retention Pond) Under Normal Flow Conditions

storage by adding a skimming outlet to prevent suspended solids and debris from entering the CD 57 system. During rain events, the pond has the capacity of 23 acre-feet of storage. The City Pond has a similar purpose to the Klein Pond, but handles primarily municipal stormwater runoff with a small portion of agricultural land. A photograph (Figure 11) shows the City Pond under normal flow conditions.

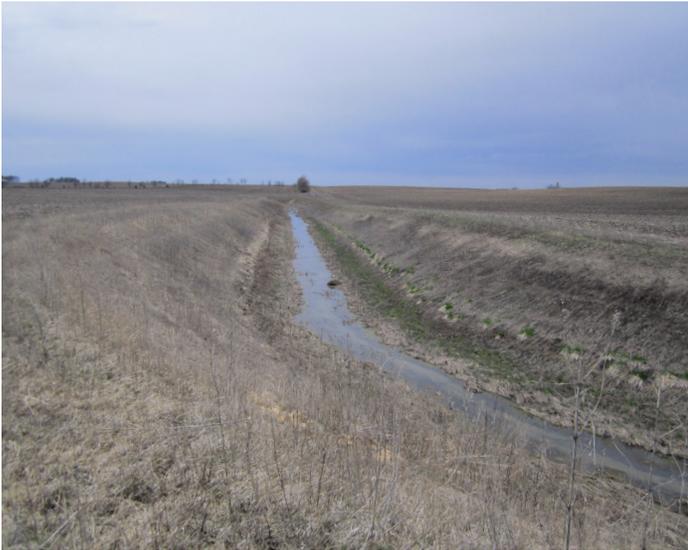
Figure 12 - Two-Stage Ditch Looking Upstream

new tile would be very large, it was more cost effective to construct an open ditch. Second, this location experiences more perennial flows from the City of Mapleton, Klein Pond, City Pond, and several tile branches that enter the ditch just upstream of this location. Therefore, this length of the ditch will more fully support the continuous flow needed to maintain fine sediment throughput and in-channel vegetation. The two-stage ditch is controlled by a 54-inch tile that connects the two-stage ditch to the open ditch on the east side of TH 22. A photograph (Figure 12) shows the two-stage ditch looking upstream towards the Klein Pond.

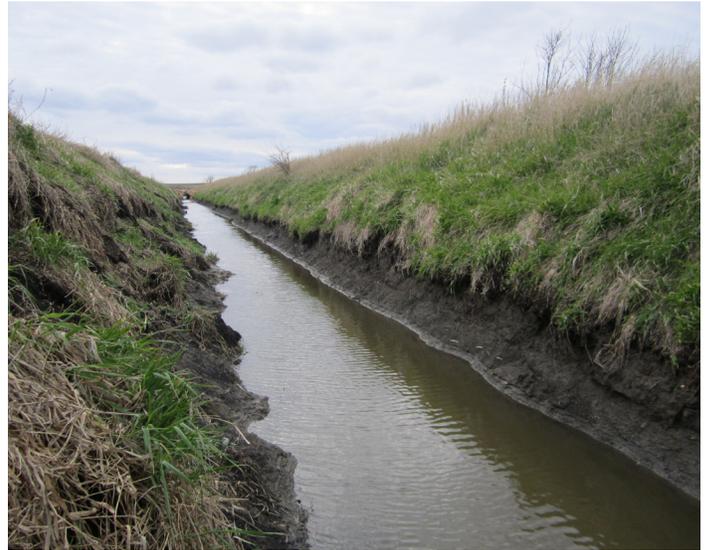
Figure 13 - Overdug Ditch Section

In addition to the two-stage ditch, a sediment trap (in-channel treatment) was constructed. This form of in-channel treatment provides an elongated linear sediment storage basin within the existing ditch channel. This section of ditch was over dug by approximately 3 feet to provide a wet sedimentation basin within the channel. The in-channel treatment includes 5,000 linear feet of ditch beginning south of TH 30 where the City Pond and mainline tile outlets into the open ditch. At this location, 1,600 acres of rural and urban runoff are treating. It then spans northeast through the Klein Pond and ends at the beginning of the two-stage ditch. This location was chosen since the area had historically high sediment transport in the ditch. A photograph (Figure 13) shows the overdug ditch downstream of the Klein Pond.

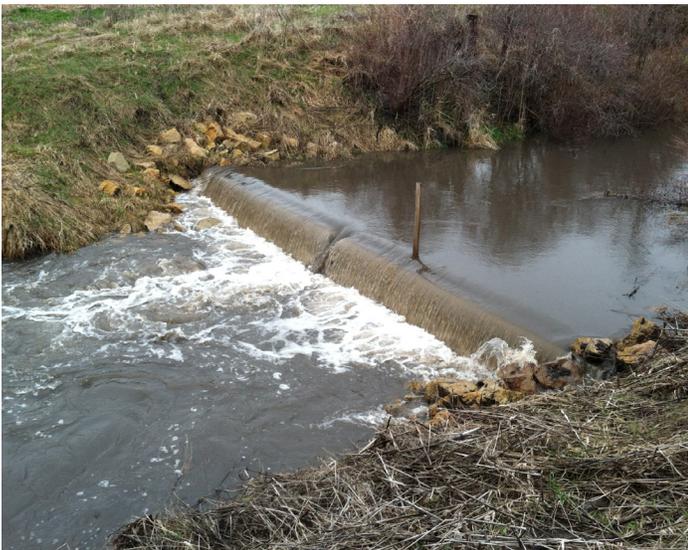
Figure 14 - Rate Control Weir After Rain Event

Highway 4. The purpose of this structure is to reduce the peak flow rates from the CD 57 system prior to discharging into the Big Cobb River. The weir reduces peak flow rates by creating a long linear pond within the open ditch, allowing sediment and nutrients to settle out of suspension. The concrete structure spans entirely across the open ditch

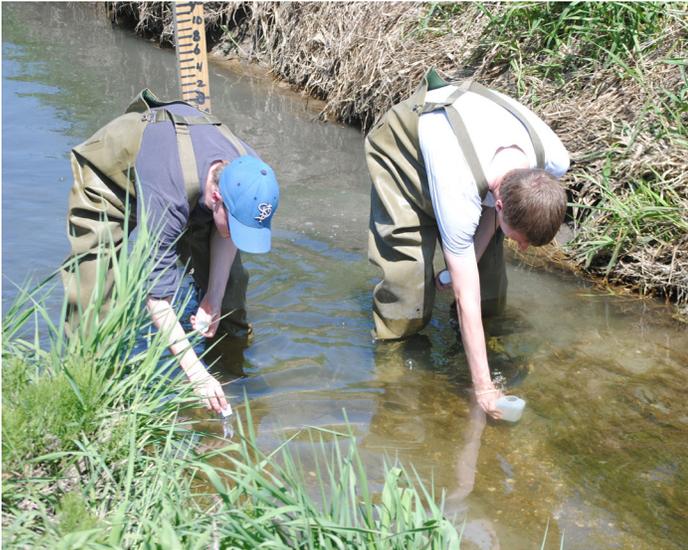
Figure 15 - MSU Students Taking Water Quality Grab Samples

and Chemistry and Geology (2012-2014). Water samples in the open ditch were measured and collected from the thalweg. Water grab samples were collected via a sampling rod or taken from the ditch. The container was filled by placing the container in the upstream direction (into the flow) without touching the bottom of the pipe/ditch channel to avoid stirring up sediment and debris (Figure 15). The sampling bottles were clean and sterile. Water grab samples were collected for E. coli (in April and October only), nitrogen (nitrate + nitrite), total phosphorus, ortho-phosphate, total dissolved solids, and total suspended solids. After collection, bottles were placed in a cooler with ice to keep samples at or below 4°C and were transported to MSU's laboratory immediately after the sampling event for immediate analysis or transfer to MVTL for further analyses.

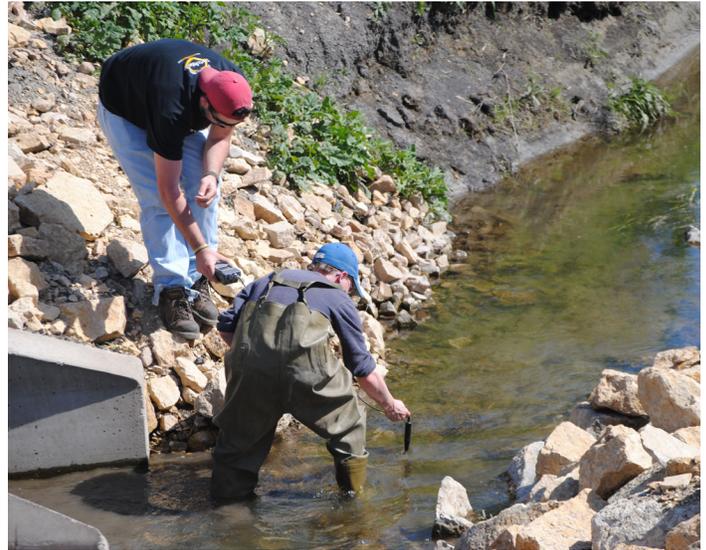
Figure 16 - MSU Students Performing Instrumental Readings

Field water quality measurements (pH, temperature, conductivity, dissolved oxygen, turbidity, and transparency tube) were collected and recorded at the site using a variety of instruments including Hanna Instruments HI 98129 and Hydrolab DS5 multi-probe sensors, Hanna HI 9142 Dissolved Oxygen Meter, and LaMotte 2020we/wi and YSI 600OMS turbidimeters. All probes were calibrated the day of sampling, before sampling begins. The probe was held at an intermediate depth in the water column without disturbing substrate materials and remained there until the probe had stabilized the reading. Figure 16 shows MSU students taking instrument readings for the aforementioned parameters.

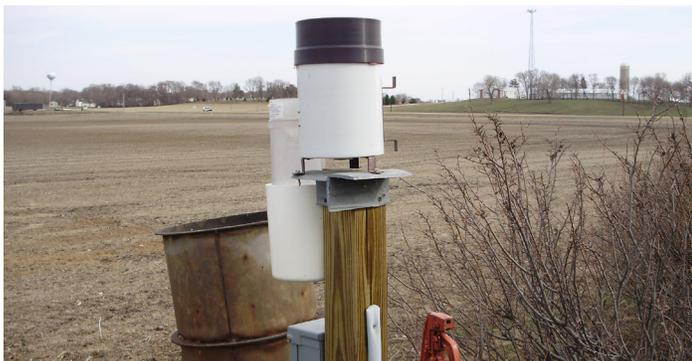
Figure 20 - Onset® RG3 Data Logging Rain Gauge

The rain gauge station is located one half mile west of the Klein Pond that was utilized to measure amount and timing of rainfall to the nearest one hundredth of an inch. This gauge was an Onset® RG3 Data Logging Rain Gauge (*Figure 20*) which provided information on the precipitation of the project area. This rain gauge includes a HOBO® Pendant Event data logging device that records rainfall data to determine rainfall rates, times, and duration. The rain gauge recorded precipitation to the nearest hundredth of an inch for any duration of a rain event. Data from the HOBO® Pendant Event data logging device was downloaded to a computer at the same time stage data was collected.

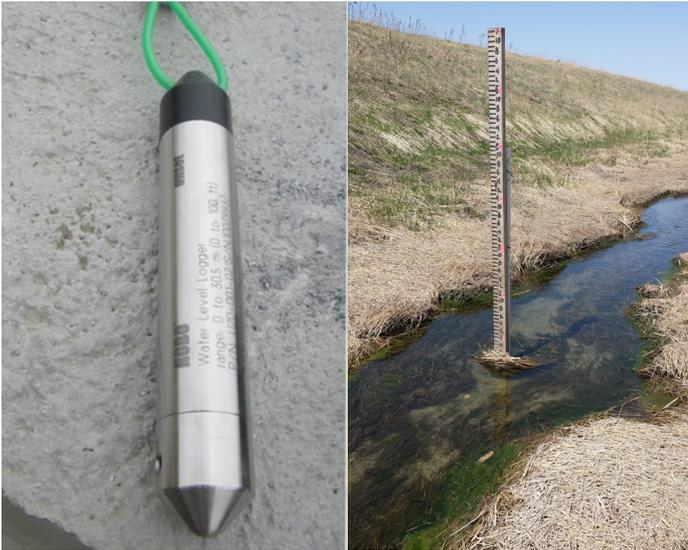
Figure 27 - Hobo Data Logging Device (left) and Staff Gauge with slotted PVC (behind) for data logging devices

Stage data were collected in 12 sites throughout the watershed by utilizing Hoboware Data logging devices that record atmospheric and hydrostatic pressure. These pressure data can then be converted to stage (depth), and incorporated into the hydrologic/hydraulic model to develop flowrates.

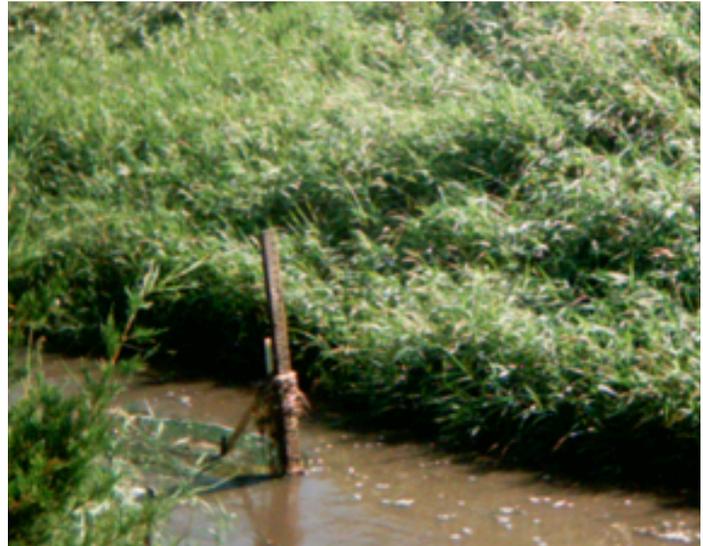
Figure 29 - 2.56 Foot Water Depth at Site 2

Utilizing Manning’s equation, approximate flow rates for all three years were calculated based on the recorded depth from the data logging devices. The following example calculation is from the July 9, 2013 rain event. After rain began to fall and water ran off into the ditch, a depth

of 2.56 feet in the ditch was recorded at Site 2. Utilizing this depth and channel geometry from the topographic survey, Manning’s equation was used to calculate flow in the trapezoidal channel.

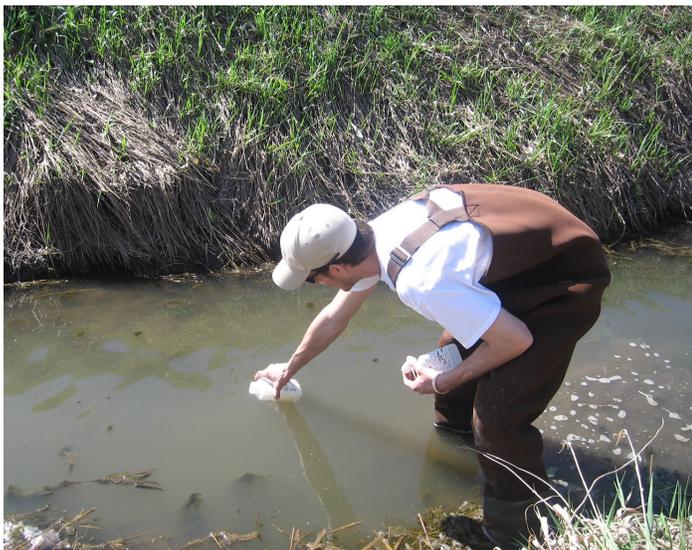
Figure 73 - Pre-BMP Installation Water Quality Grab Sampling (ISG)

All pre-BMP installation monitoring was performed by ISG with water quality samples analyzed by Minnesota Valley Testing Labs (MVTL). Water quality samples and flow data were collected from the thalweg (deepest continuous inline within a water channel) of the open water channel. Water quality grab samples were collected for: total suspended solids, fecal coliform, E. coli, nitrogen (nitrate + nitrite), total phosphorus, ortho-phosphate, and suspended volatile solids. Samplings were collected by facing a clean, sterile sampling bottle upstream into the flow to ensure no influence of disturbed water due to wading; facing upside down, and submerging elbow deep water and inverting the bottle until filled (Figure 73). Nutrient bottles (nitrogen- nitrates + nitrites, total Kjeldahl nitrogen, and total phosphorus samples) contain 5 mL of 10 percent H₂SO₄ solution for preservation purposes. The bottles were narrow mouth, high-density polyethylene natural cylinder bottles with plastic and poly-foam 19 lined caps. After collection, bottles were placed in a cooler with ice to keep samples at or below 4°C. Samples were then transported to MVTL in New Ulm, Minnesota within 24 hours for analysis. A chain-of-custody was filled out before and while samples were at MVTL.

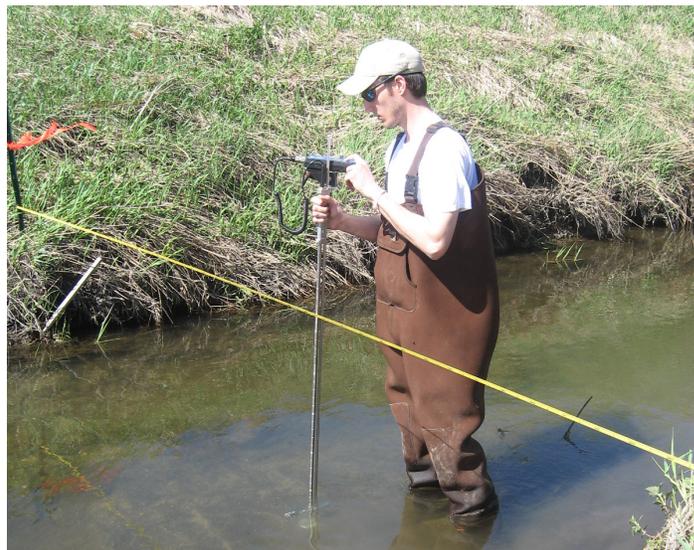
Figure 74 - Pre-BMP Installation Flow Sampling (ISG)

For the monitoring period prior to construction, flow measurements were obtained for a cross section of the channel at each of the three monitoring locations. Flow was measured using the Pygmy Flow meter according to methodology described in Harrelson et al. (1994). Flow was measured at the same sampling location (identified by GPS) and was primarily recorded during baseflow conditions due to the hazard of sampling after rain events. To measure flow, a tape was spread from one side of the stream bank to the other. The tape was secured above the surface and pulled taught. The entire distance of the channel was recorded. Depth and velocity are recorded beginning at the edge of the bank where it meets the water (Harrelson et al. 1994). If no water was present at this location, 'no flow' was marked and subsequent measurements were taken at every 10 cm along the tape (Harrelson et al. 1994). The velocity measurements were converted to discharge using the formula provided by the manufacturer. Figure 74 shows pre-BMP installation flow measurements in the open ditch portion of the system.
