## **2011 Project Abstract**

**PROJECT TITLE: Restoration Strategies for Ditched Peatland Scientific and Natural Areas**

**Final Report**

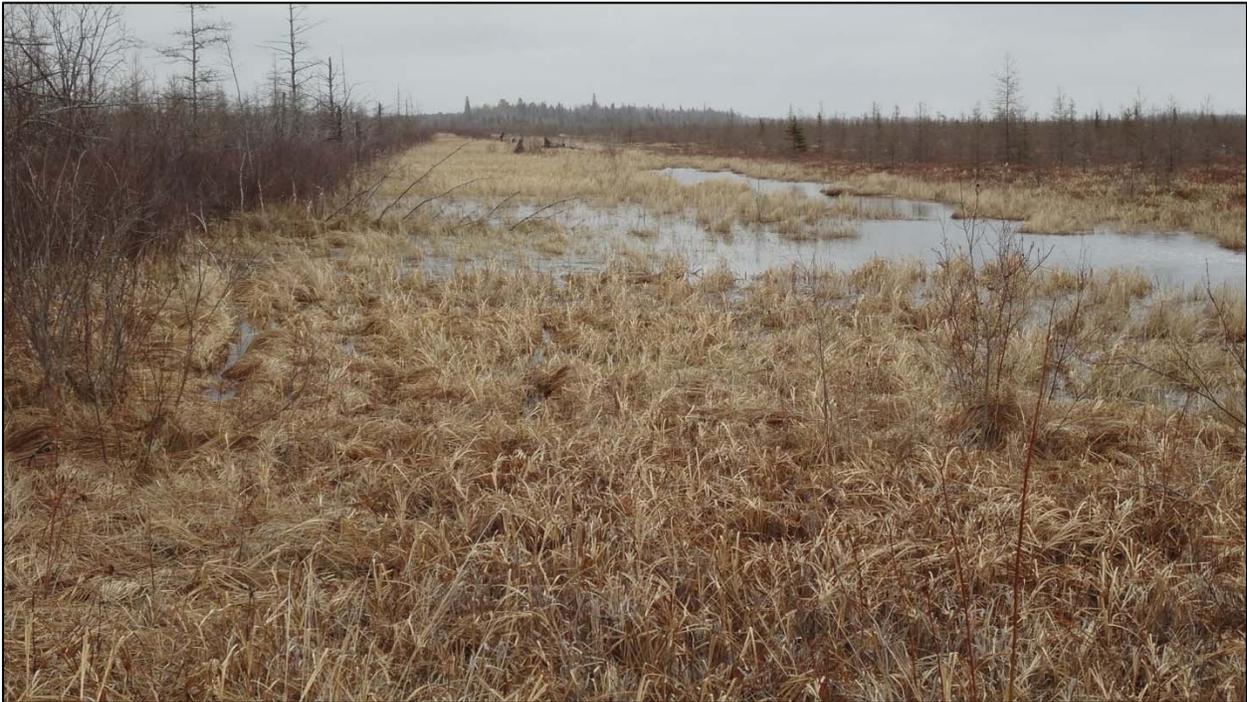
**Figure 2:** Clay core ditch block at the Brown’s Lake Peatland Restoration site. May 2014.

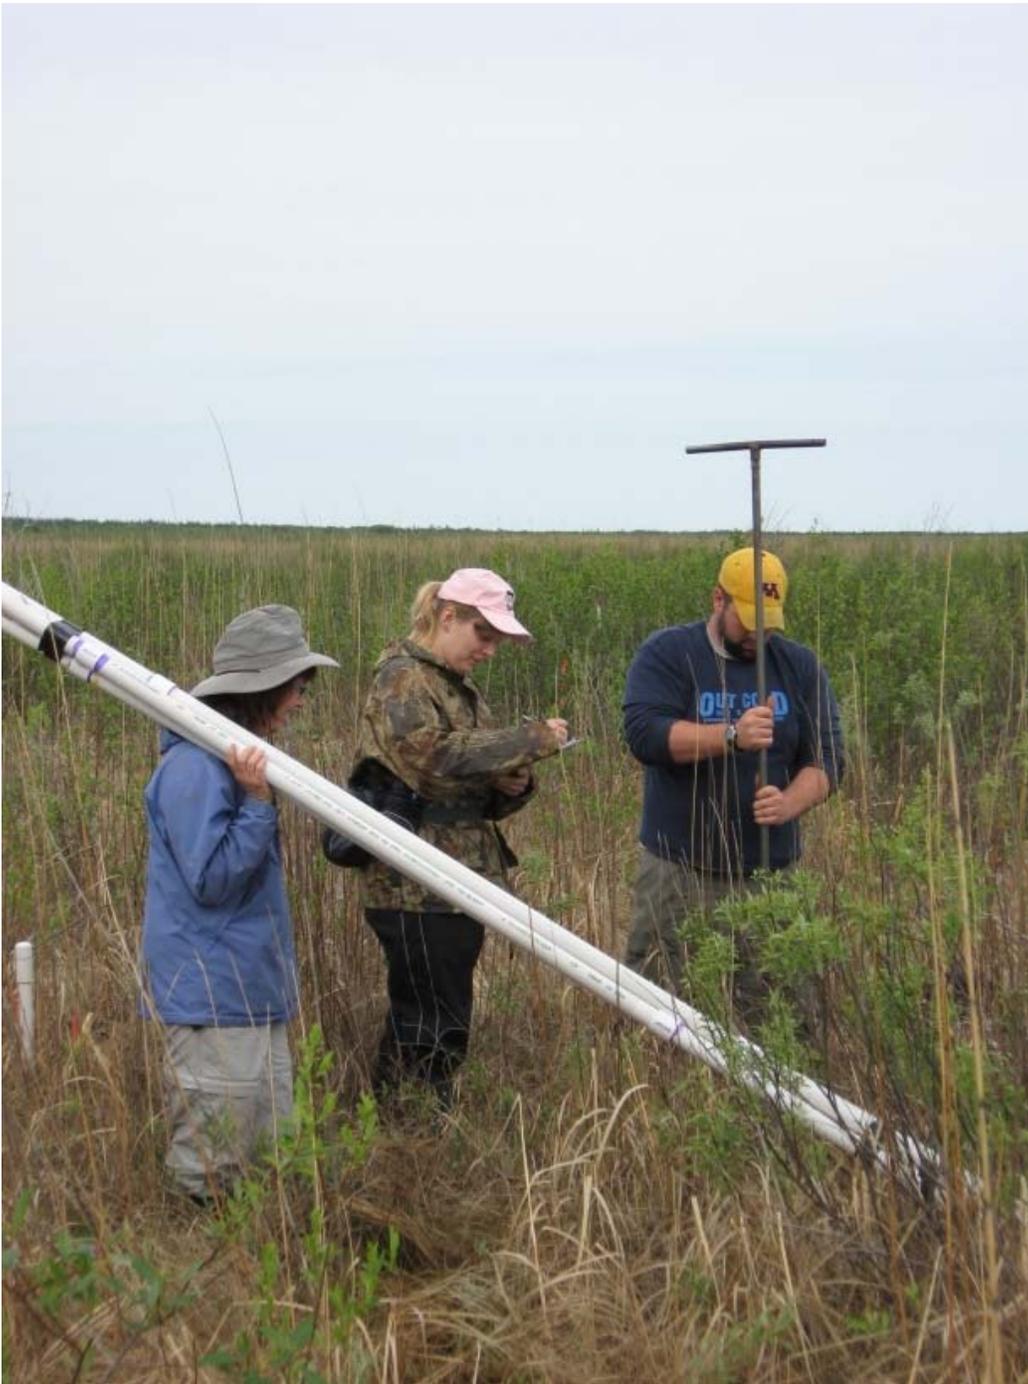
Step 4b: Bring pre-constructed piezometer out to site

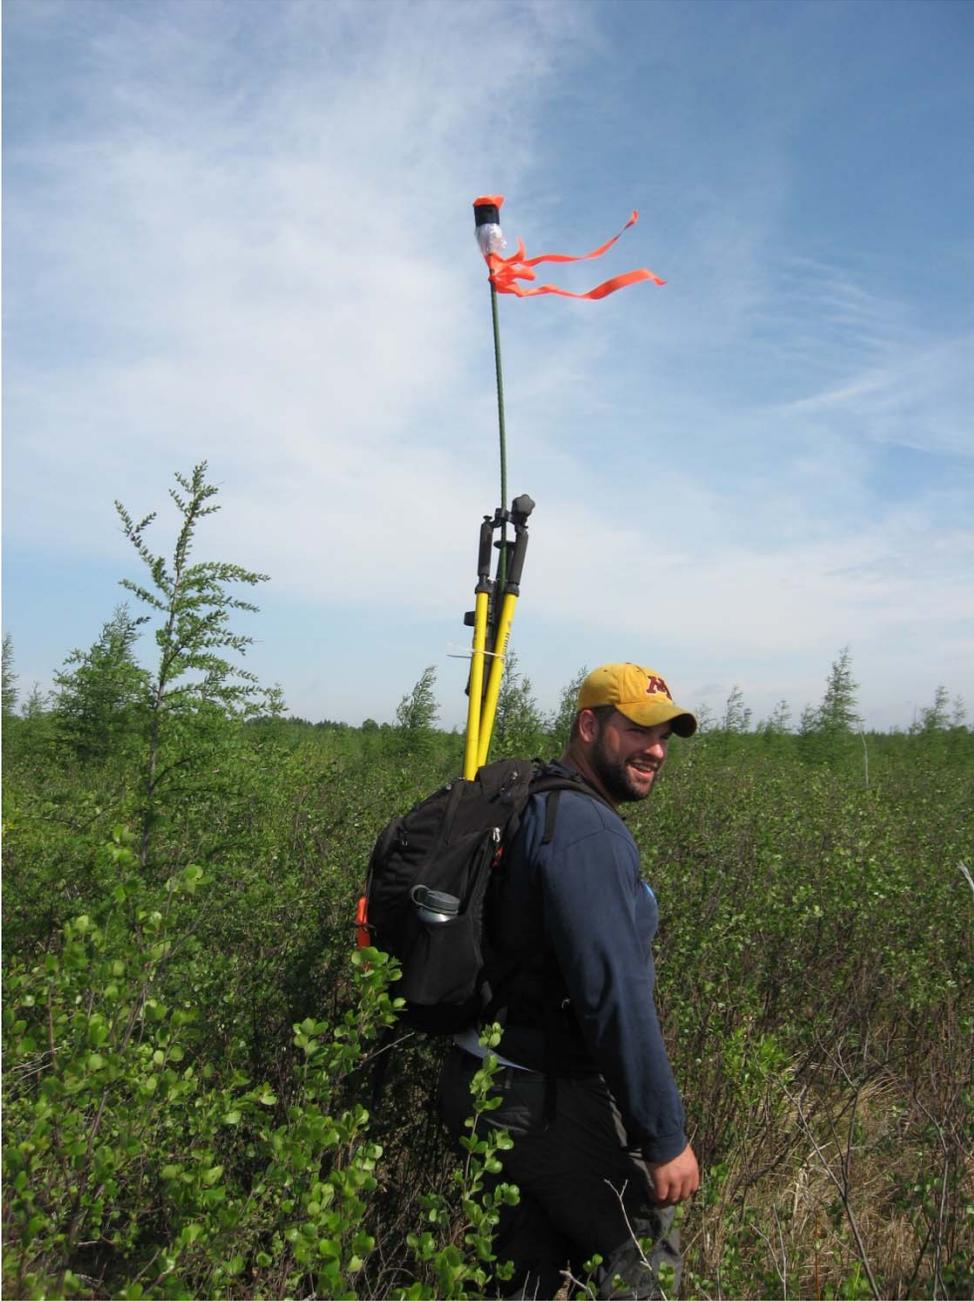
Step 8: Survey well locations and top of casing elevation.
